Effect of Annealing and Etching on Machining Damage in Structural Beryllium

JAMES E. HANAFEE

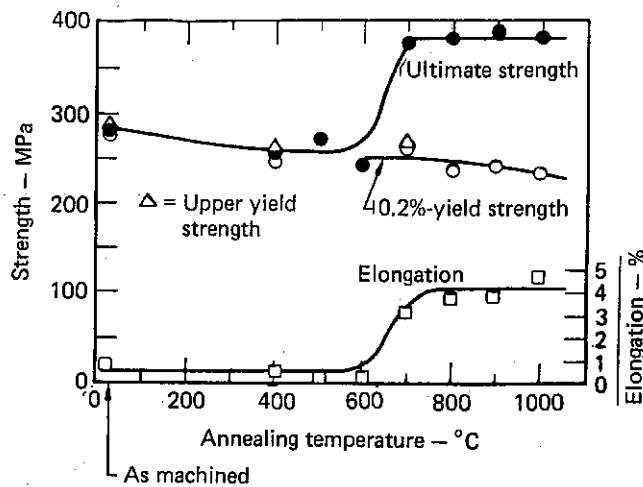
Fig. 1—Effect of 1-h anneal at various temperatures on the mechanical properties of machining-damaged 1319A beryllium.

Table II summarizes the data obtained on all specimens in this study. Figure 1 shows the effects of machining damage and subsequent annealing for the 1319A beryllium. For this beryllium grade in the as-machined condition, the ultimate strength and the elongation at fracture were quite low. Annealing at temperatures up to 600 °C (1112 °F) did not significantly change these mechanical properties. However,

annealing at a temperature of 700 °C (1292 °F) did substantially increase both the ultimate strength and the elongation. Higher annealing temperatures—up to 1000 °C (1832 °F)—did not further improve these two properties. Thus the deleterious effect of the machining operation was removed by 1 h of annealing at temperatures of 700 °C (1292 °F) or above.

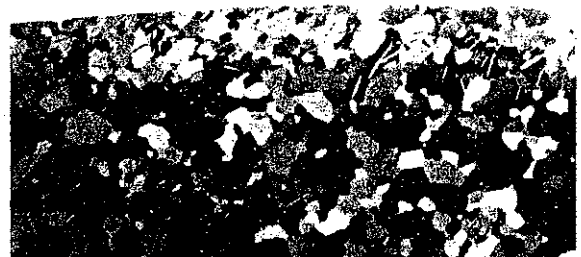
Fig. 9—Effect of 1-h anneal at various temperatures on the microstructure of machining-damaged S200E beryllium.

The changes in optical microstructure with annealing were similar to those observed for the 1319A beryllium (Fig. 9). Annealing up to 600 °C (1112 °F) produced no changes; twinning and highly distorted grains are still present. Annealing at 700 °C (1292 °F) recrystallized the microstructure in the first 50 μm (0.002 in.) from the specimen surface but left a band between approximately 50 and 100 μm (0.002 and 0.004 in.) that contains twins. Annealing temperatures of 800 °C (1472 °F) and above removed all evidence of machining damage.

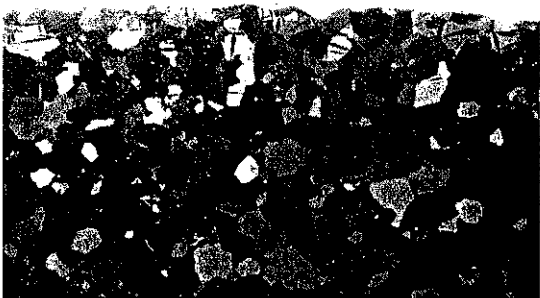
Fig. 13—Effect of chemical etching on the microstructure of machining-damaged S200E beryllium.

As in the microstructure of the 1319A beryllium, the S200E grade appears to still contain a significant amount of machining damage after chemical removal of 25 μm (0.001 in.) of material (Fig. 13). The remaining damage is primarily twinning to depth of 25 to 50 μm (0.001 to 0.002 in.) and some grain distortion in the first 25 μm (0.001 in.). The presence of this machining damage did not lower the ultimate strength or elongation from the certified values shown in Table I.
